Comprehensive
Car Inspection Report

Hyundai Verna

SX1.5VTVT IVT | 2020 | AT | Petrol

Inspection location: Gurgaon

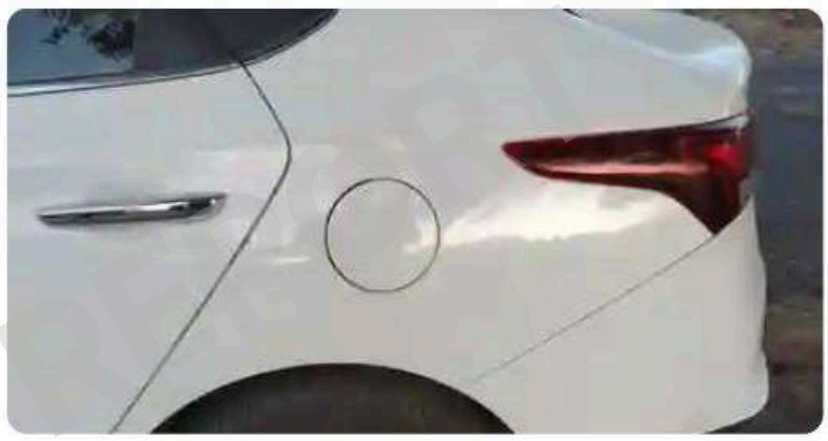
Roof: No Dents, Scratched

Bonnet/Hood: No Dents, Scratched

Dicky Door / Boot Door: No Dents, Scratched

Quarter Panel LHS: No Dents, Repainted

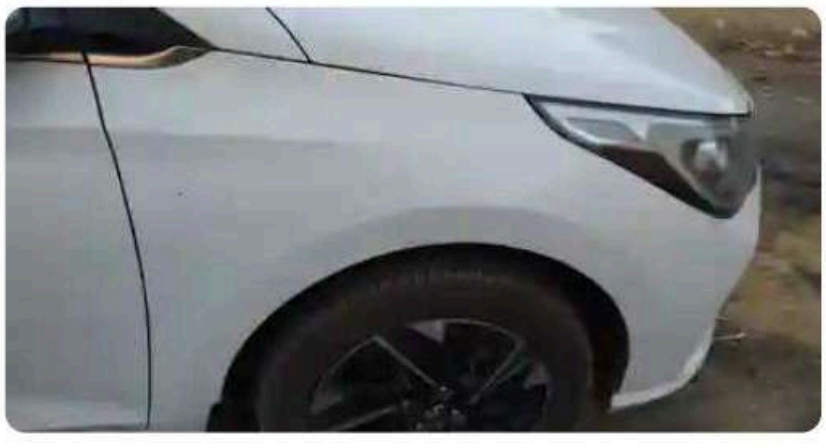
Fender LHS: No Dents, Scratched, Repainted

Fender RHS: No Dents, Repainted

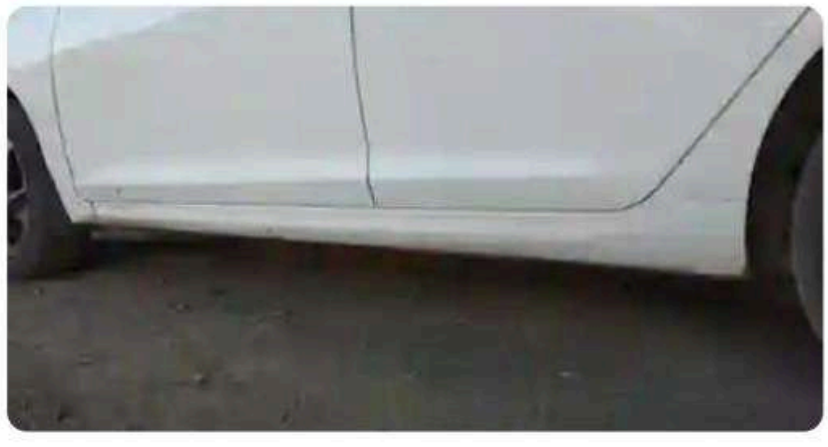
Running Border LHS: No Dents, Scratched, Repainted

Running Border RHS: No Dents, Repainted

Door LHS Front: No Dents, Scratched, Repainted

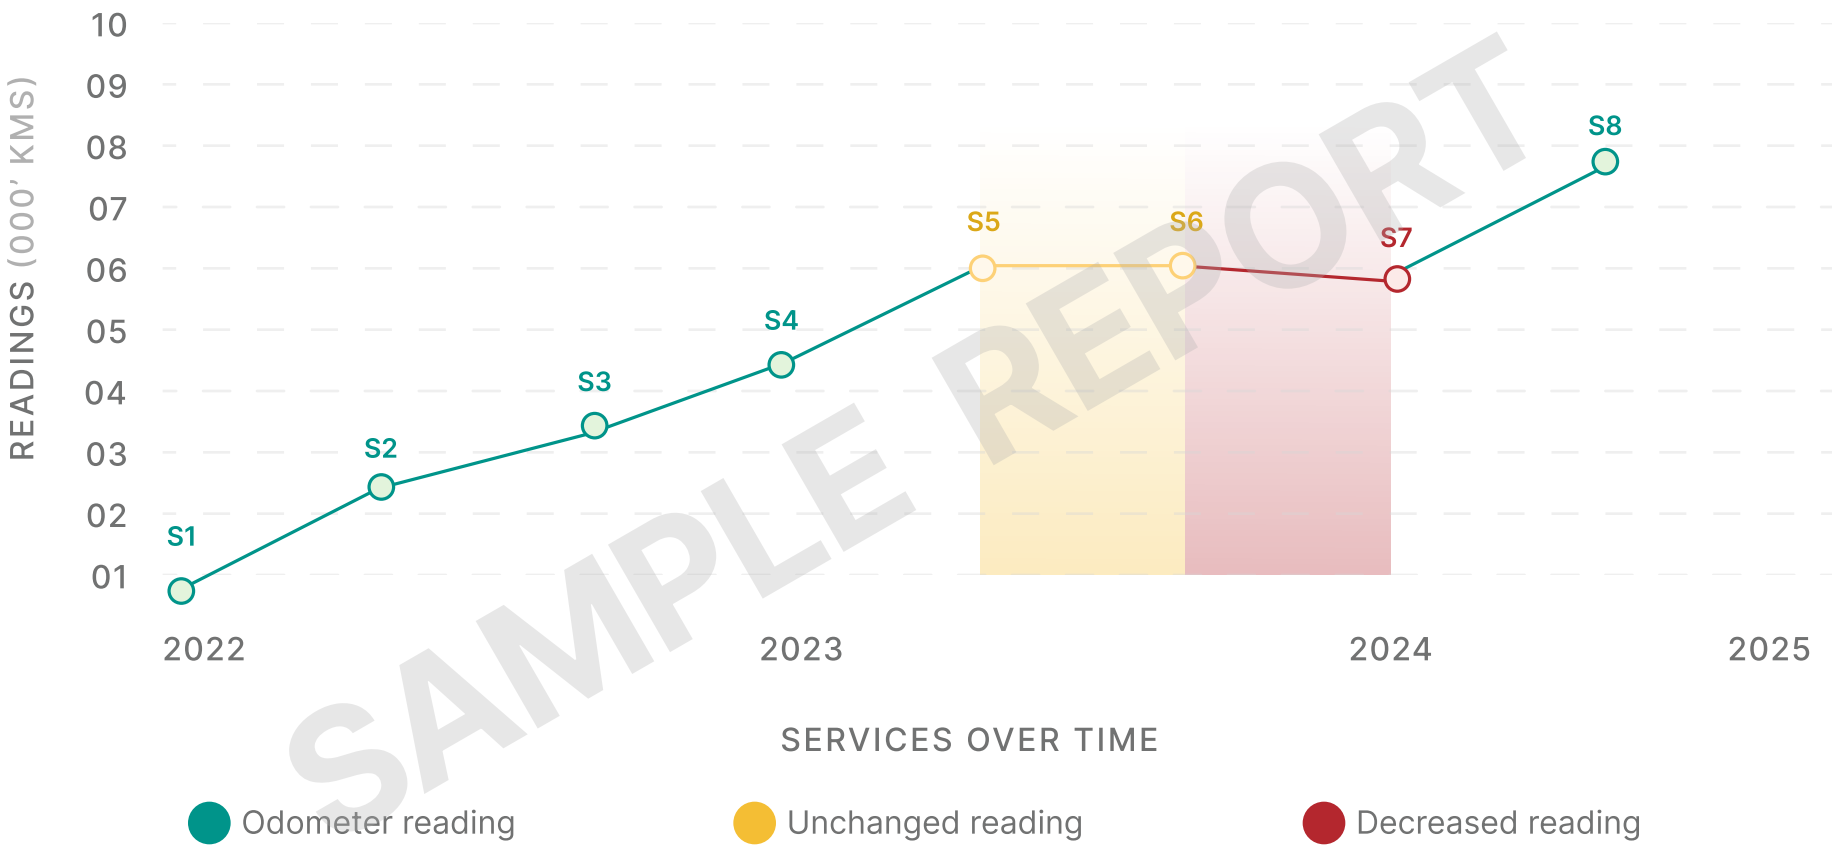
Odometer has been tampered once

The odometer has been tampered 01 time till now before the 7th service of the car. Since the odometer reading went down from S6 to S7.
